BACKGROUND INFORMATION

PROCESS IMPROVEMENTS

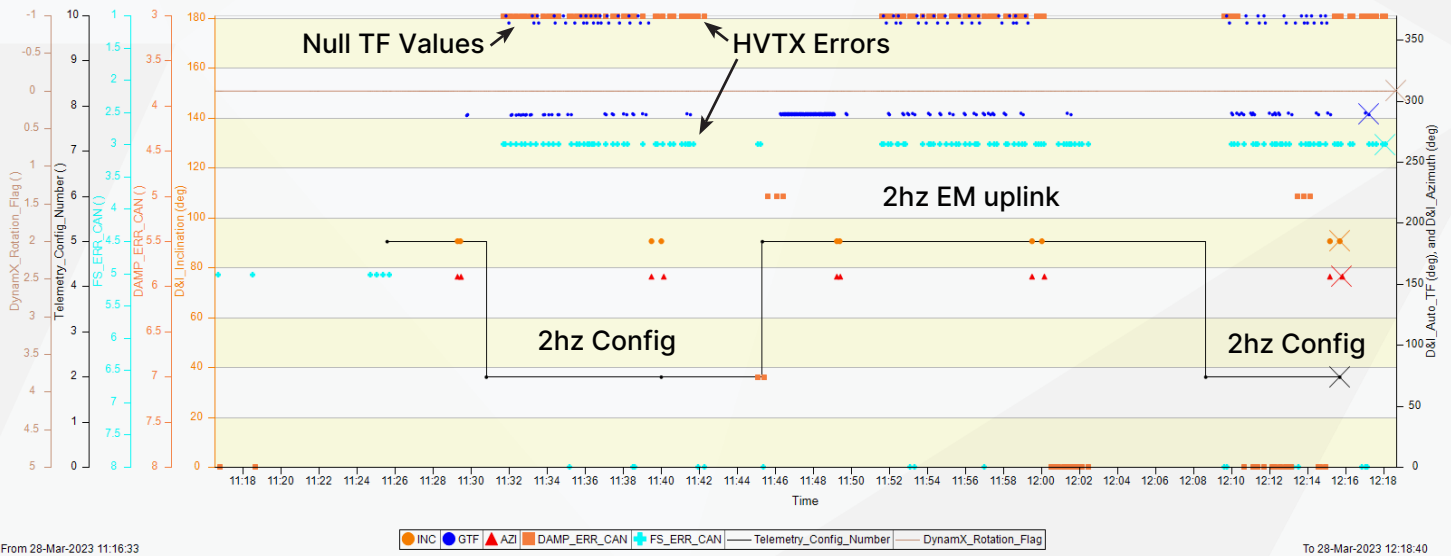
Electrical noise from EM transmission in 2Hz/2cycle in some applications can interfere with internal tool string communications, resulting in null toolfaces observed in operations. The issue has been reproduced in lab testing after multiple confirmed reports from the field.

Below is logged data from one of the tests conducted to replicate the issue. Whenever the string was set to transmit in 2hz several HVTX errors would start to occur and tool faces would intermittently be sent and recorded as null values. These are seen as -8888 decodes on the surface gear and tool faces above 360° in the memory.

2 Hz configurations should be avoided for use in the field. 2.5Hz configurations have been proven to not cause the issues in bench testing and field use. The engineering team will continue to evaluate the situation and advise when and how 2 Hz configurations can safely be used in the future.

- This notice identifying the problem when using 2hz with XEM will be distributed to all clients who currently use this technology in the field.
- Future configurations will also remove 2hz/2cy uplink parameters and replace those options with 2.5hz/2cy. Contact Command if you need replacement configurations generated.
- The command center and all training personnel are now aware of the issue and know the steps to troubleshoot the issue if it appears.
